In 1998 Senior Public Works Inspector of Santa Monica, CA, Richard Valeriano, had a dream in which sidewalks were flexible, not rigid. This led to trials using small rubber pavers instead of concrete near large ficus trees with roots causing repetitive concrete damage.

The following slides—known as the 21st Street Study—document the behavior of tree roots beneath a modular, lightweight system (such as Rubbersidewalks™) over a five year period. They show that trees can be preserved and maintained, and that their roots need not be dangerously cut off.

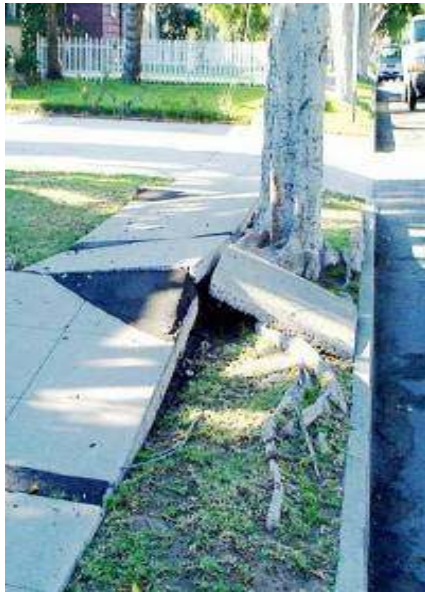
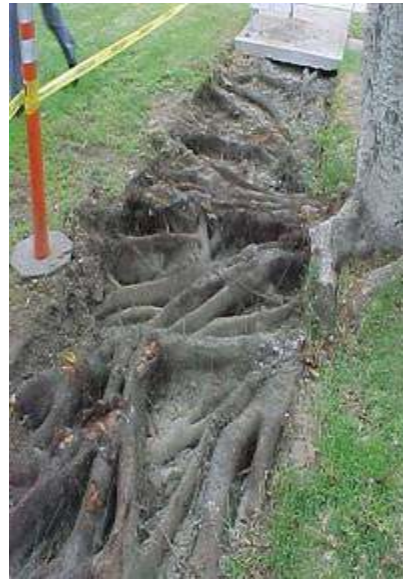
Pre-Study 1988-2000

- The previously existing concrete sidewalk next to mature ficus tree was repaired twice over a 12 year period. Each time concrete was severely damaged by tree roots.

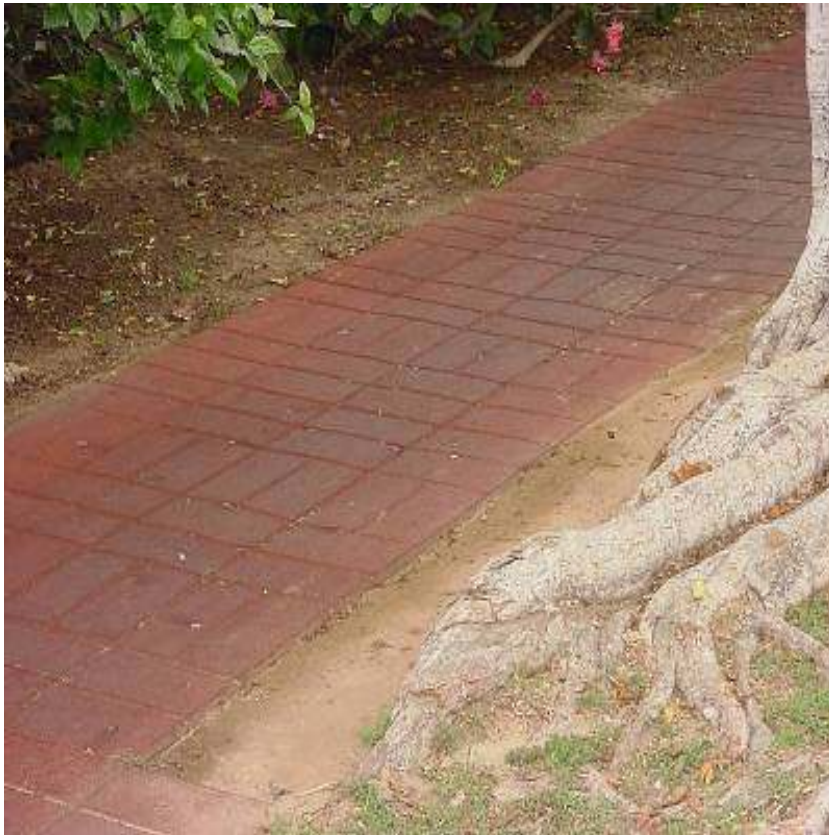
Installation – April 2000

- 120 square feet rubber pavers installed next to ficus tree
- Pavers are 1'x2.5'x2" rectangles and have no connection feature
- Above grade roots directionally trimmed
- Two Sections to be studied, A and B
- Both Sections remain untouched for 27 months

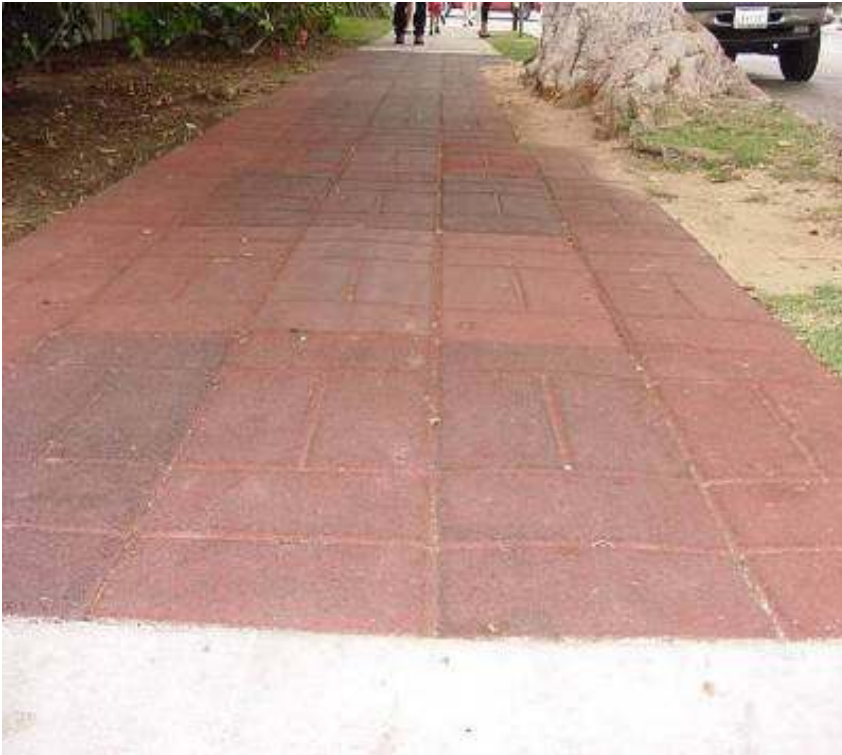
Section A - First Maintenance July 2002

- Two years after installation pavers are slightly faded and harder
- Pavers remain on grade and have 'settled'
- No disruption or dislodgement has occurred

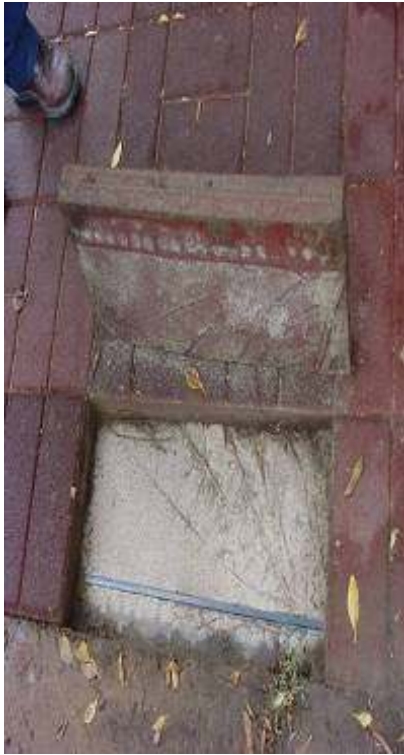
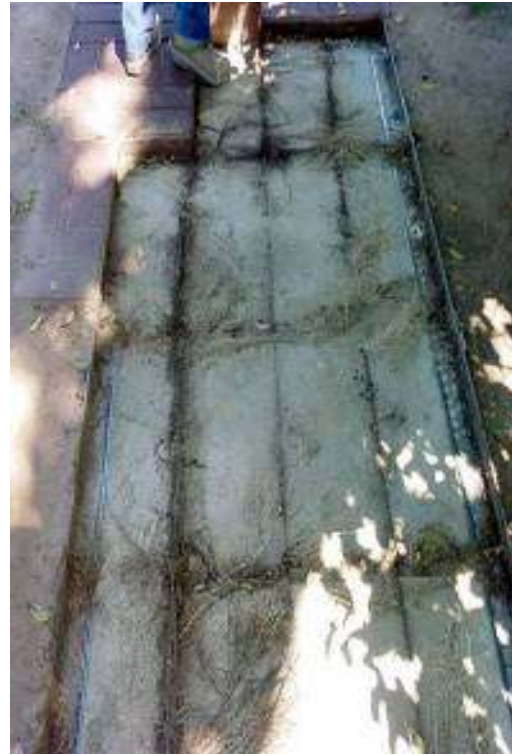
Section A - First Maintenance & Discovery

Pavers are removed and roots exposed

Tree has produced thin, fine offshoots or “scout roots”

Scout roots start in fan-like pattern then grow along seams of paver joints.

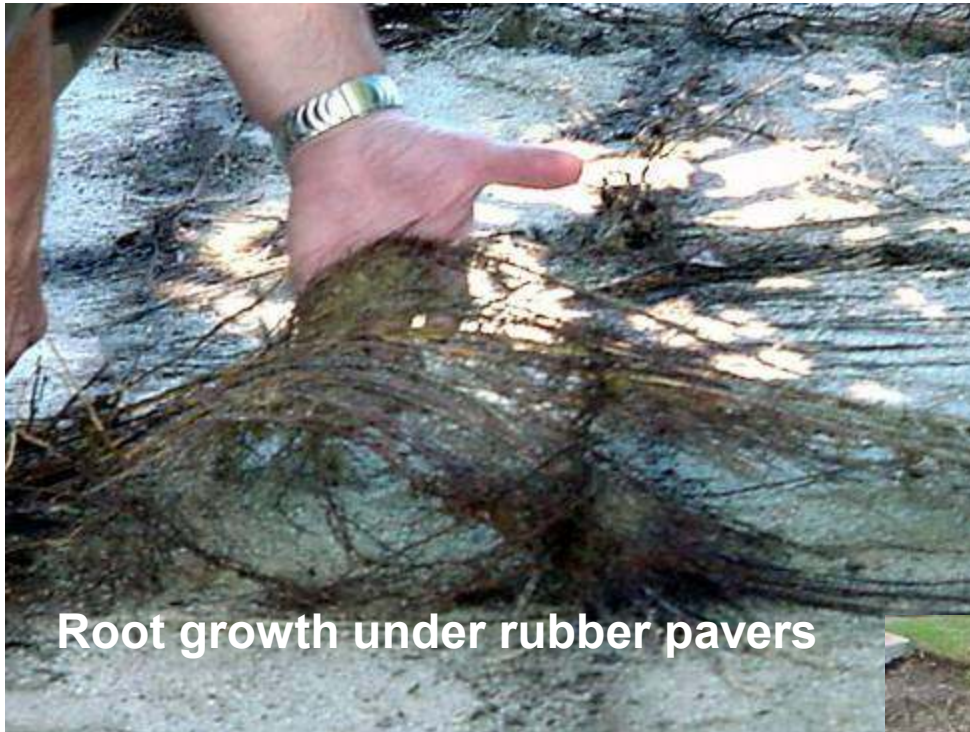
Root growth under rubber pavers

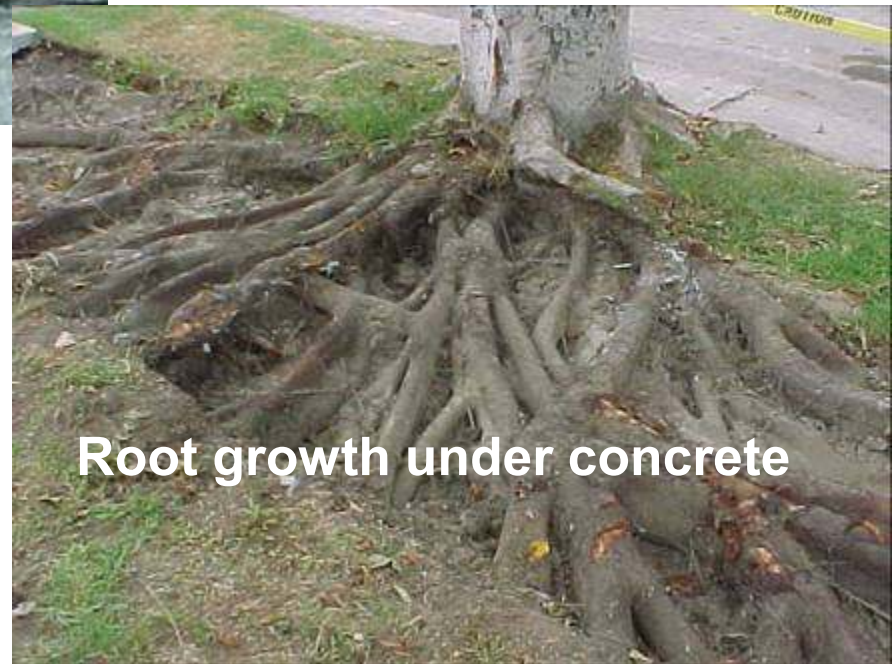
Root growth under concrete

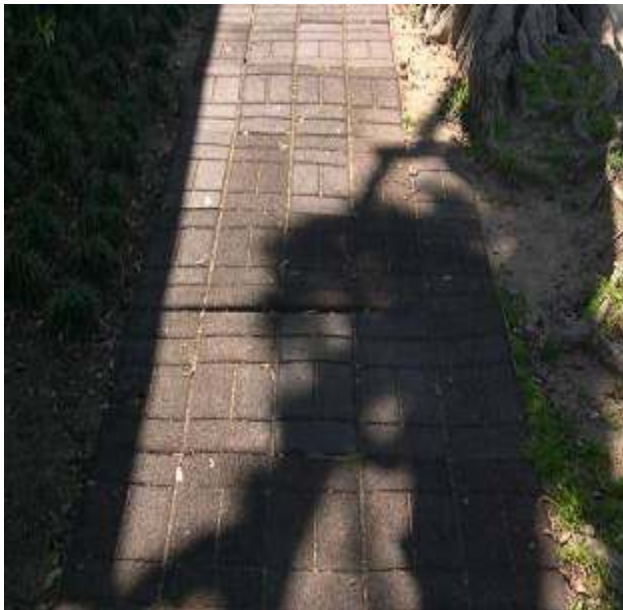
March 21, 2005

- Section B
First Maintenance in
5 years
- Section A
Second Maintenance after
2.75 years

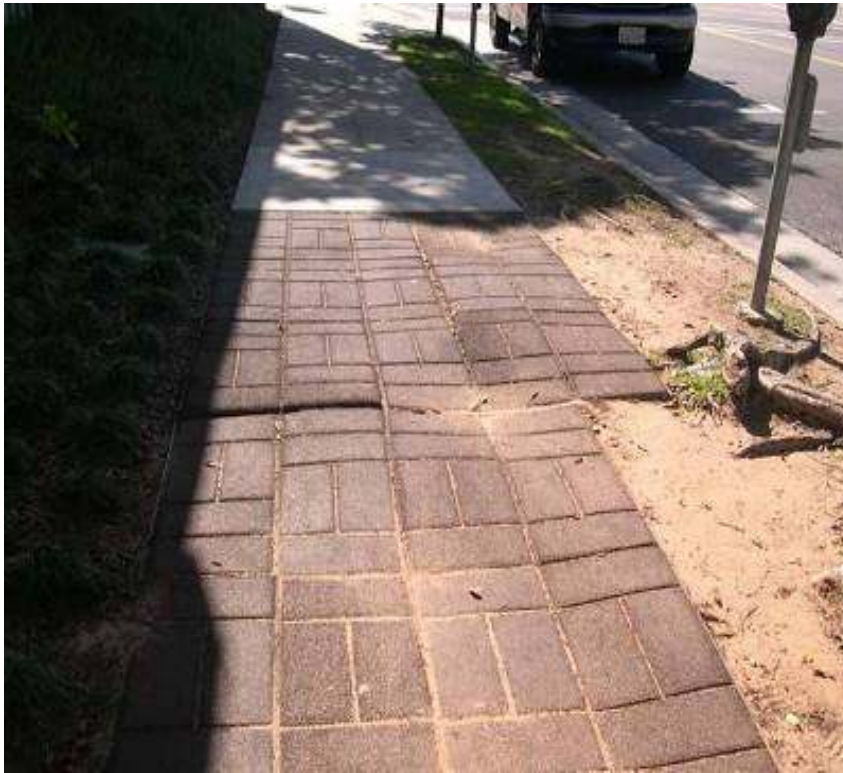
Section B First Maintenance (Pavers not touched in 5 yrs)

- Paver displacement and undulation slightly greater than in 2002
- Discoloration and increased hardness
- Surface wear same as Section A (indicates change in base but not much in product)

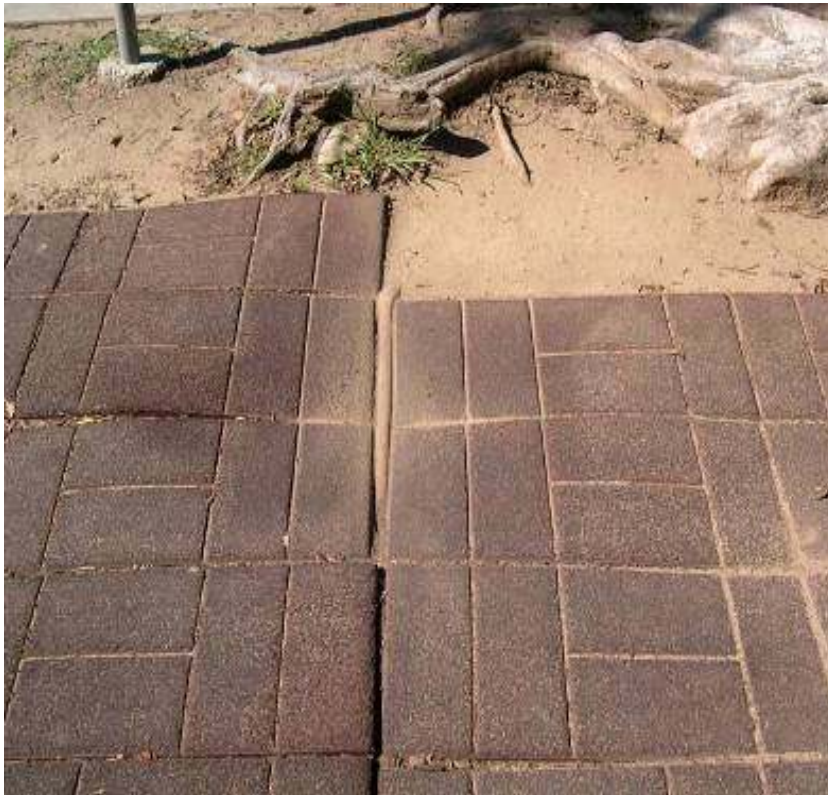
Section B First Maintenance

- Two seams are pushed open by underlying roots
- One root measures 1.75" in diameter

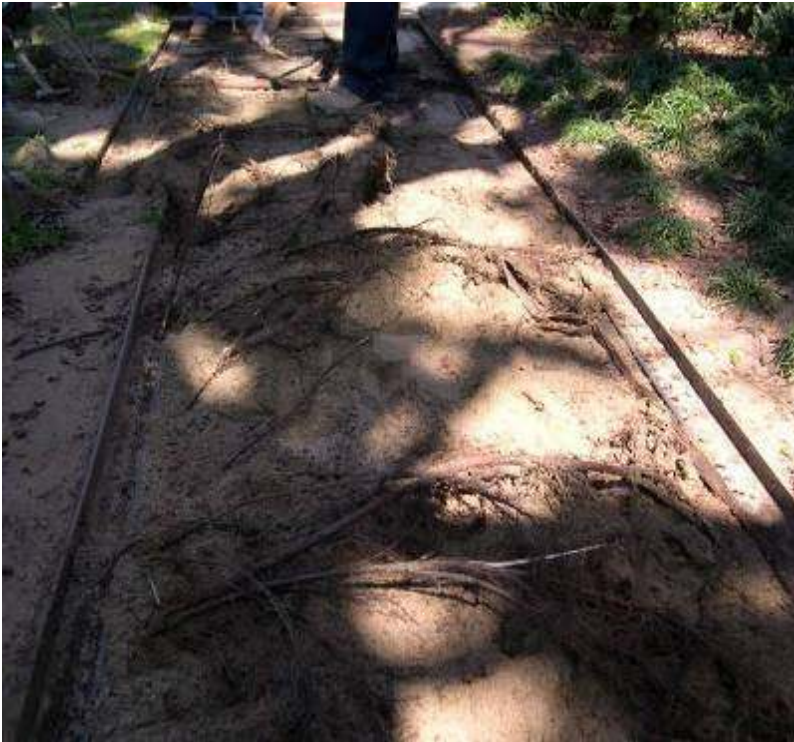
Section B First Maintenance Discovery, March 2005

- Pavers are removed
- Find same number of roots and same growth pattern as Section A, but these roots are larger
- All roots grow along seams
- Roots grow so straight along seams that they resemble pipes; indicates roots grow where they find air, water and space

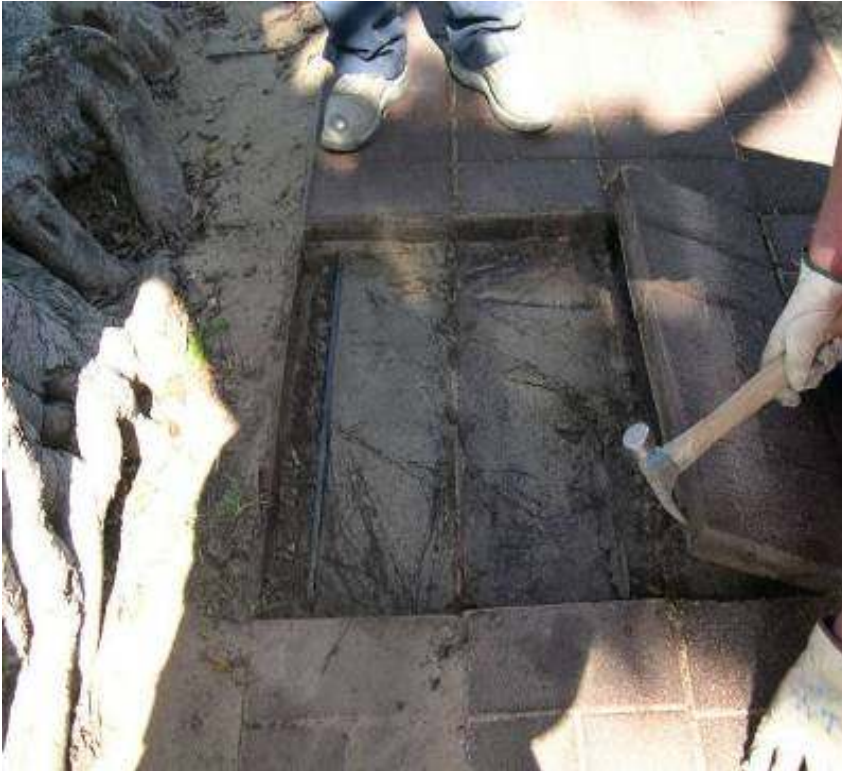
Section A - Second Maintenance, March 2005

- Pavers show further discoloration and brittleness comparable to Section B
- No roots visible in any seams
- One area of displacement, and uplift of 1/2"

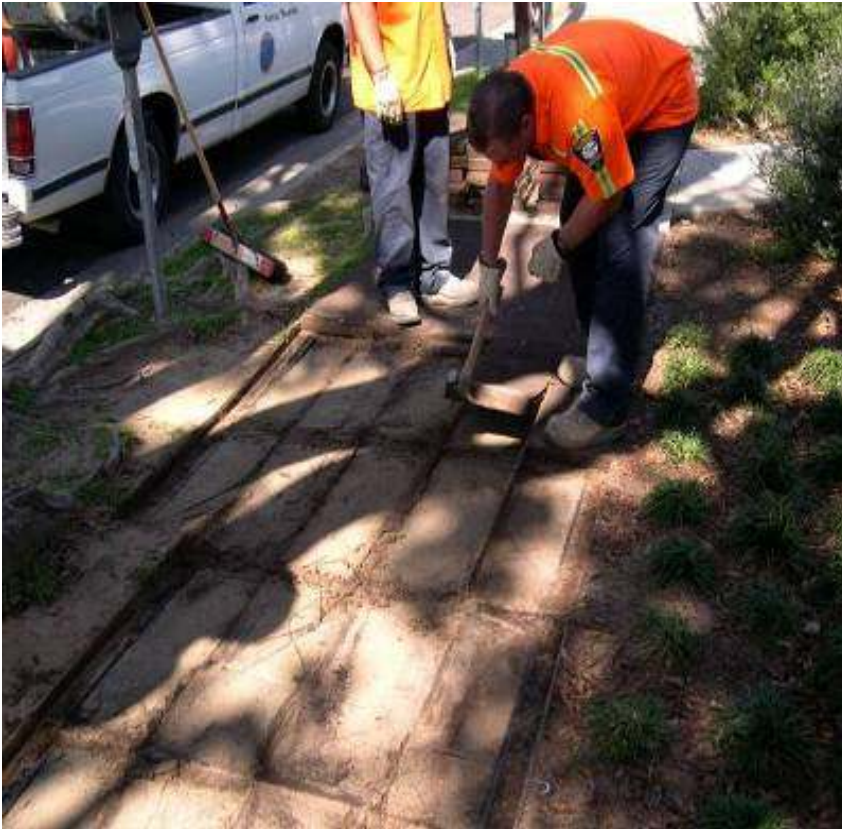
Section A - Second Maintenance, March, 2005

- Pavers are removed with 2 workers in 7 minutes
- Fewer offshoots are found than in 2002
- Smaller volume of roots
- Roots still follow the seams of the pavers

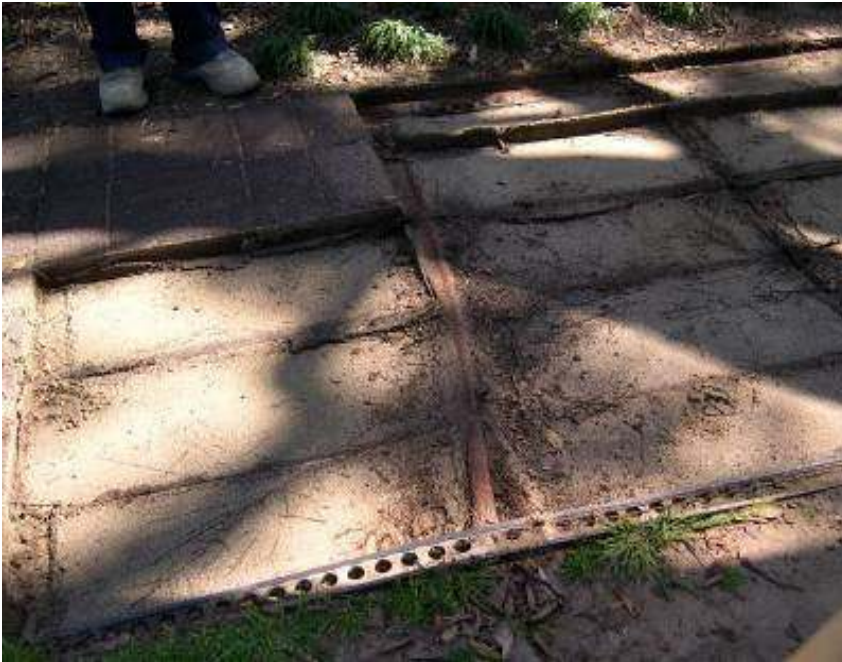
Section A - The Exceptional Root

- One large root stood out, undoubtedly one missed in the first maintenance
- By studying this root and comparing it to other root growth, discoveries are made:

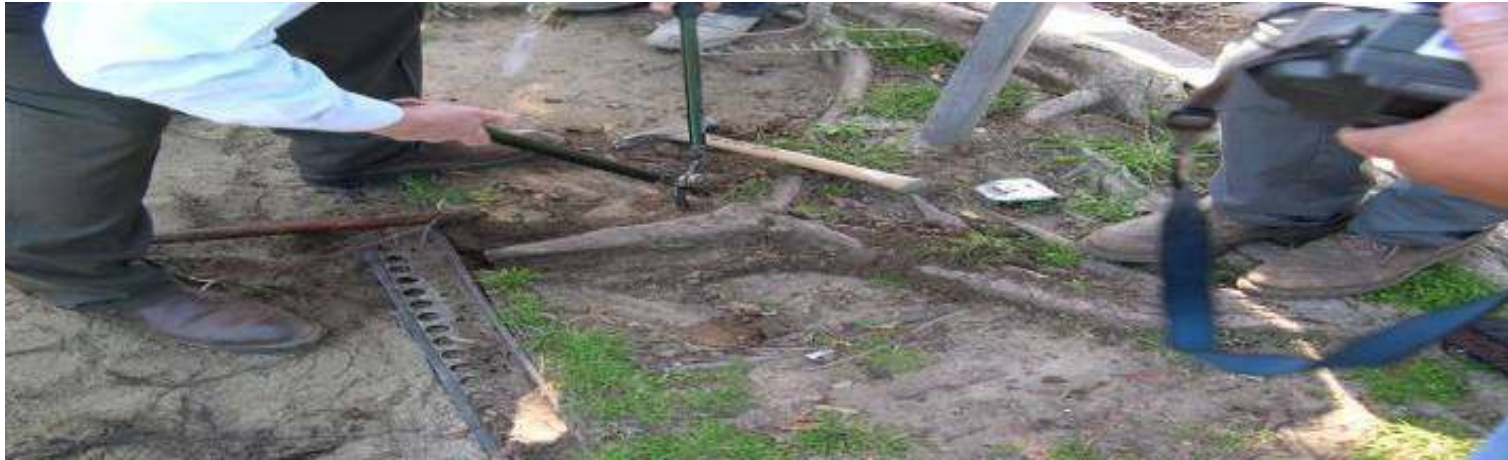
The Exceptional Root: Discoveries

- 1) If a root can be traced back to the last “nub” and directionally trimmed at that spot, the future direction of new offshoot growth can be controlled and even predicted.

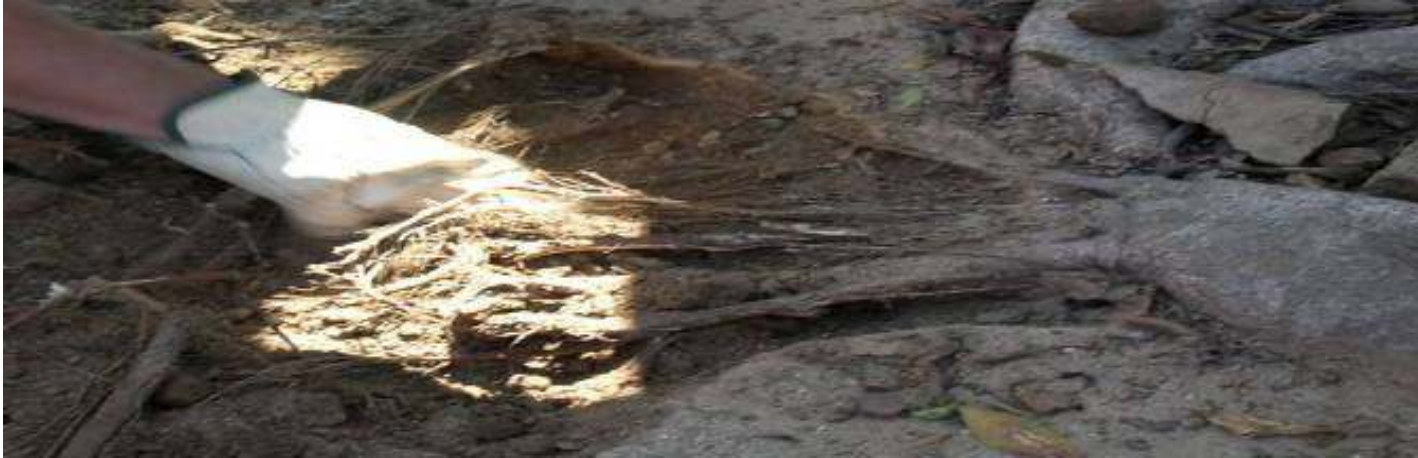
The Exceptional Root: Discoveries

- 2) It was demonstrated that if offshoots can be traced back to its source and trimmed, the root can be directed to produce fewer offshoots in the future.

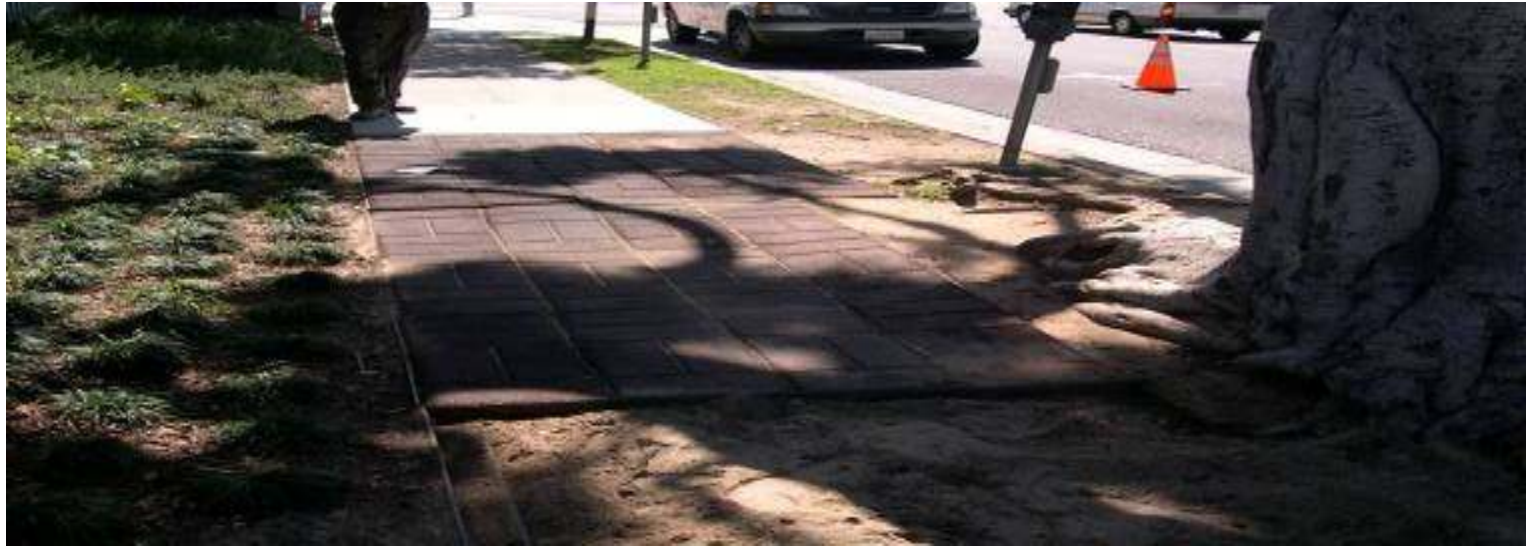
The 21st Street Study: Discoveries

- 3) It is speculated that the first trimming of the scout roots may have modified their behavior and conditioned them to grow elsewhere than under the pavers.

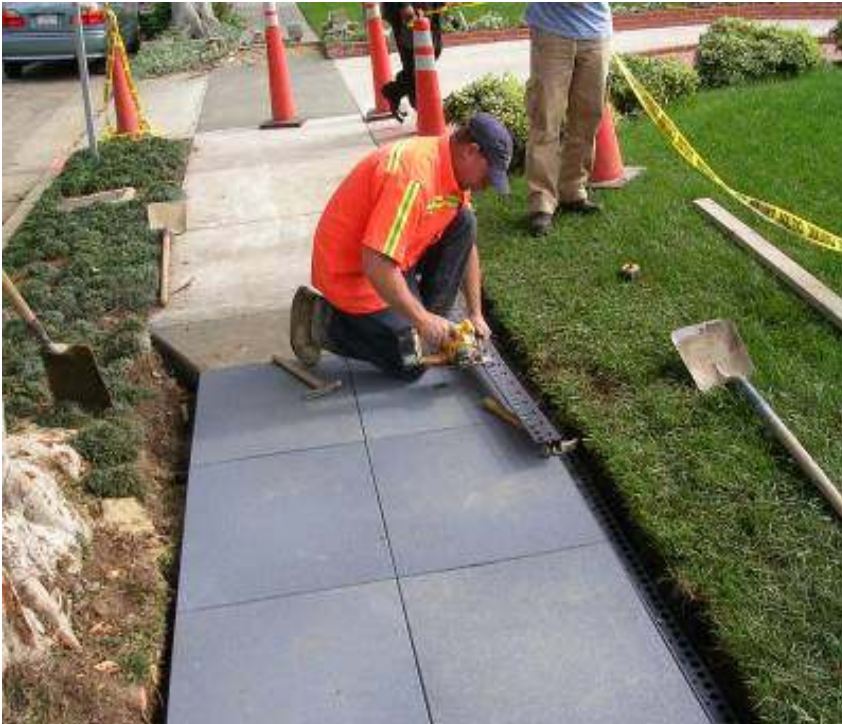
City of Santa Monica, 2005

- The city has installed over 4,000 sq. ft of Rubbersidewalks at more than 40 locations.

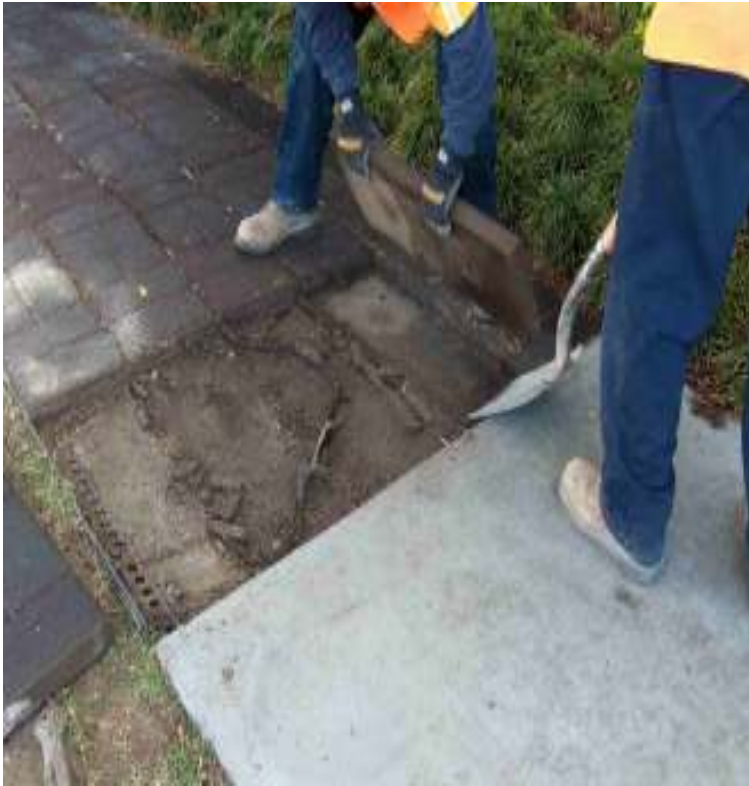
Conclusions: Five years post install

1) Comparing observations of Section B after 5 years, to Section A after 2.25 years and again after 5 years, leads one to believe that periodically exposing roots—an opportunity afforded by a modular system like Rubbersidewalks™ promotes tree well-being, and savings.

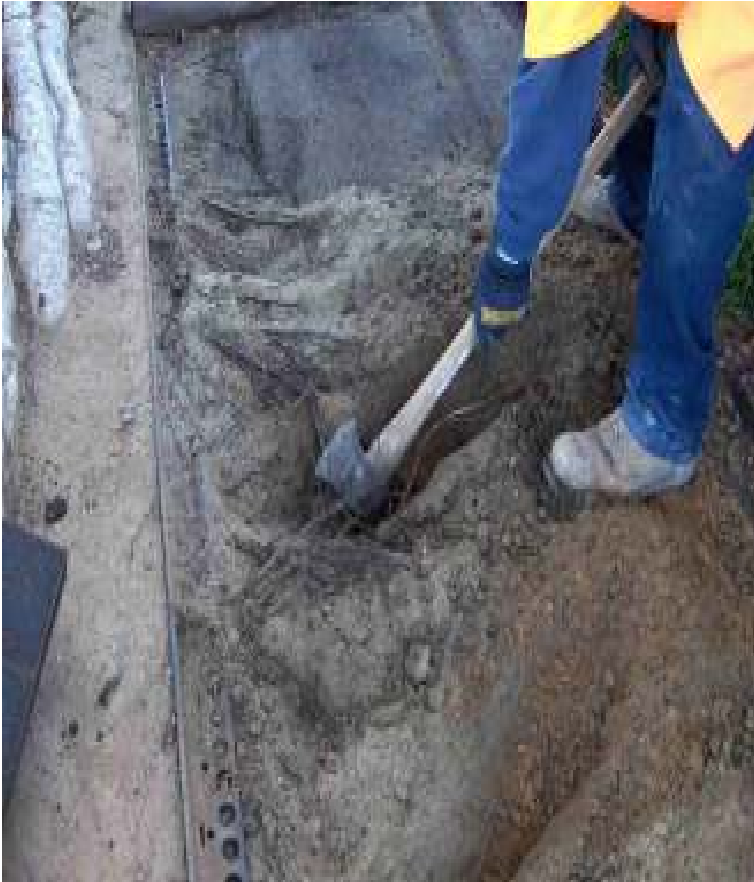
Conclusions: Five years post install

2) New root growth (offshoots, scout roots, absorbing roots) are produced in great volume initially. If pruned in these early stages: first two-five years of production, the tree will continue to produce new offshoots but less of them.

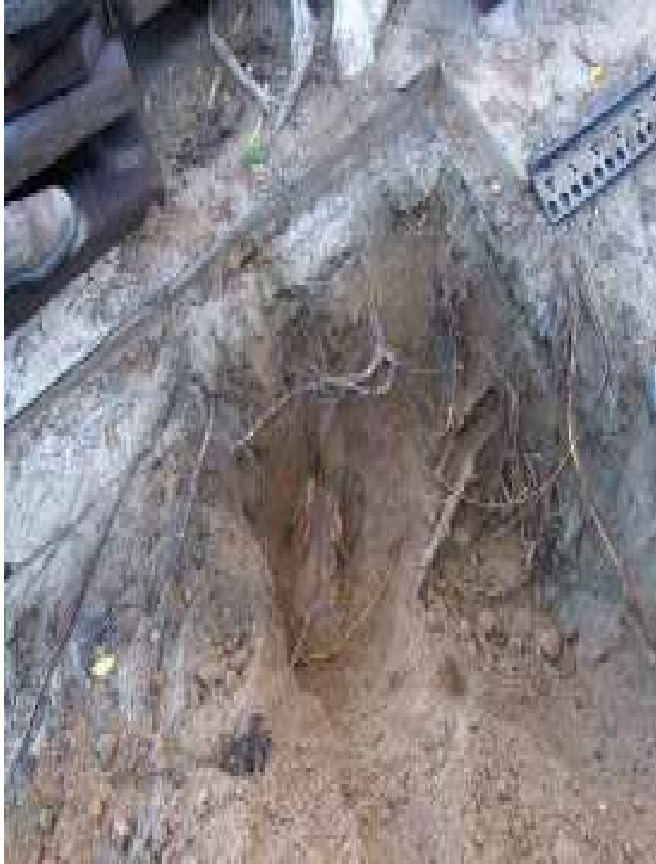
Conclusions: Five years post install

3) Taking advantage of this opportunity to expose and prune roots in the first 5 years will have long term results and effectively control root growth by diverting the surface root growth to a deeper level or alternate path of root growth.

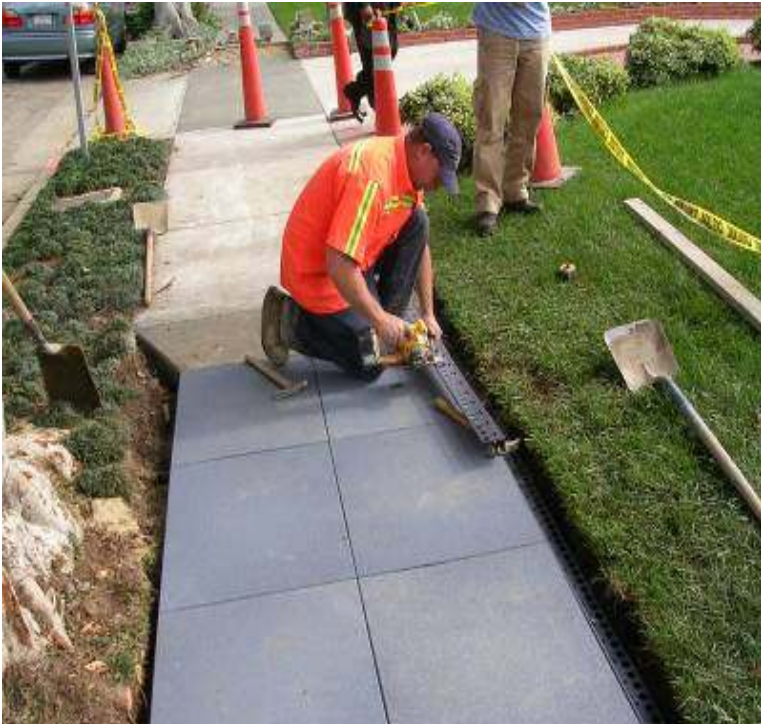
Conclusions: Five years post install

4) Maintaining the health of tree, reducing size and volume of root growth, and diverting root growth, is served by 'midcourse adjustment' (maintenance) after two to five years.

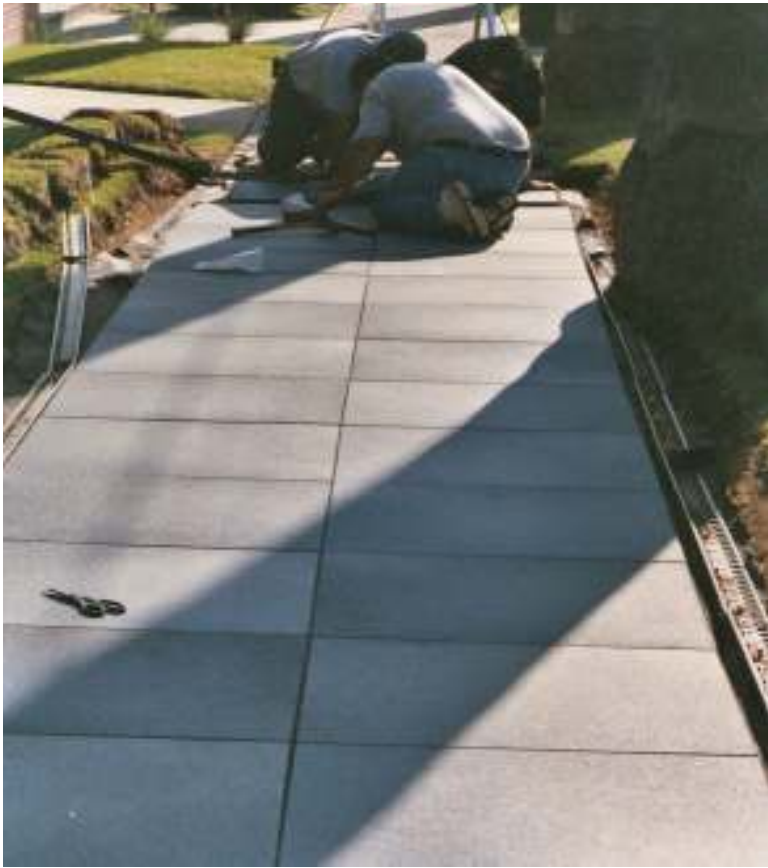
Conclusions: Five years post install

5) Concrete would not have presented such opportunities and most likely would have been cracked or displaced no later than third year.
